Mining operations on ports

Issued June 2018

Spotlight on Mines Safety Significant Incident Report No. 184

Shiploader rail clamps fail after original parts modified in unsuccessful attempt to overcome problem of rail misalignment

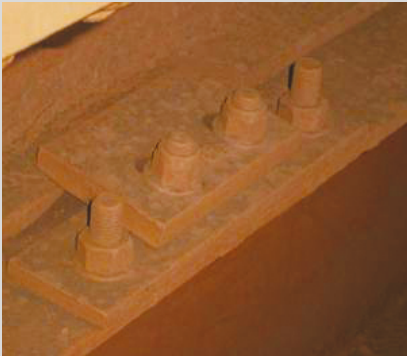
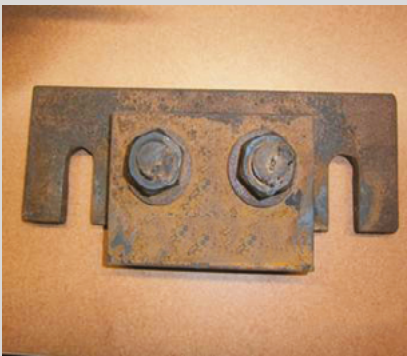
Photographs showing rail clamp as designed by original equipment manufacturer (top) and modified rail clamp (bottom) with open-ended slots and welded nuts and bolts

Before making repairs, a competent person should determine the root cause of the failure and how to address the underlying problem. Alternate or modified parts should be assessed by a competent person as meeting the original equipment manufacturer's performance specifications.
