Outbreak of fire

Issued August 2018

Department of Mines,
Industry Regulation and Safety

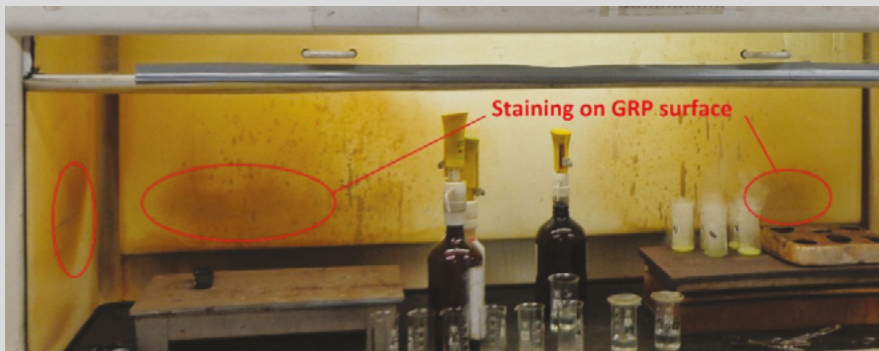
Fire in processing plant laboratory

- Maintenance of the fume cupboard, as recommended by original equipment manufacturer (OEM), was not undertaken.
- Inspections by the certified service provider did not identify the fire hazard of the damaged gel coating on the rear wall panel.
- Risk assessments did not identify fire risks associated with acid digest processes.
- There was no fire rated collar installed between the exhaust vent and laboratory wall.
- The laboratory building was of a sandwich foam panel construction, with no fire retardant properties, and no fixed fire-suppression system in place.
