SIGNIFICANT INCIDENT REPORT NO: 129

Derailment and fall of overhead Crane

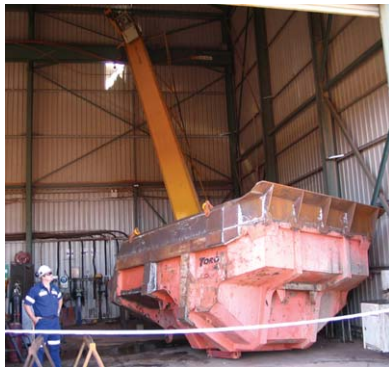
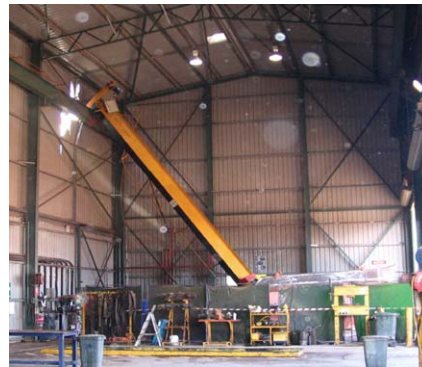
During the final manoeuvre the lifting chains were adjusted and the tub was raised to lie at an angle to assist in the turning process. The tub was lowered and the crane was moved to re-centre the load. The tub tipped over and the crane suddenly began to move uncontrollably hitting the long travel end stops upon which it derailed. One end of the crane fell into the tub. The boilermaker was in very close proximity to the tub when the crane fell.

The tub was not centralised under the crane. In the final tipping manoeuvre when the tub was in contact with the floor, the tipping of the tub caused a sudden change in the load distribution and exerted a side-pulling effect, which caused an uncontrolled and accelerated movement of the crane when the crane was engaged to travel. This led to the flanged wheels of the long travel carriage closest to the tub riding up on their track and derailing just before hitting the long travel end stop thus causing the crane to fall.

The suitability of the crane for the task was also questionable.

The company concerned is assessing its needs for a replacement crane eg investigating whether the type/capacity crane is suitable for the task being performed at the time of the occurrence. The company is also ensuring the measures mentioned below are carried out.
