Significant Incident Report No. 208

Subject: Bystander struck by component ejected from accumulator

Date: 17 November 2014

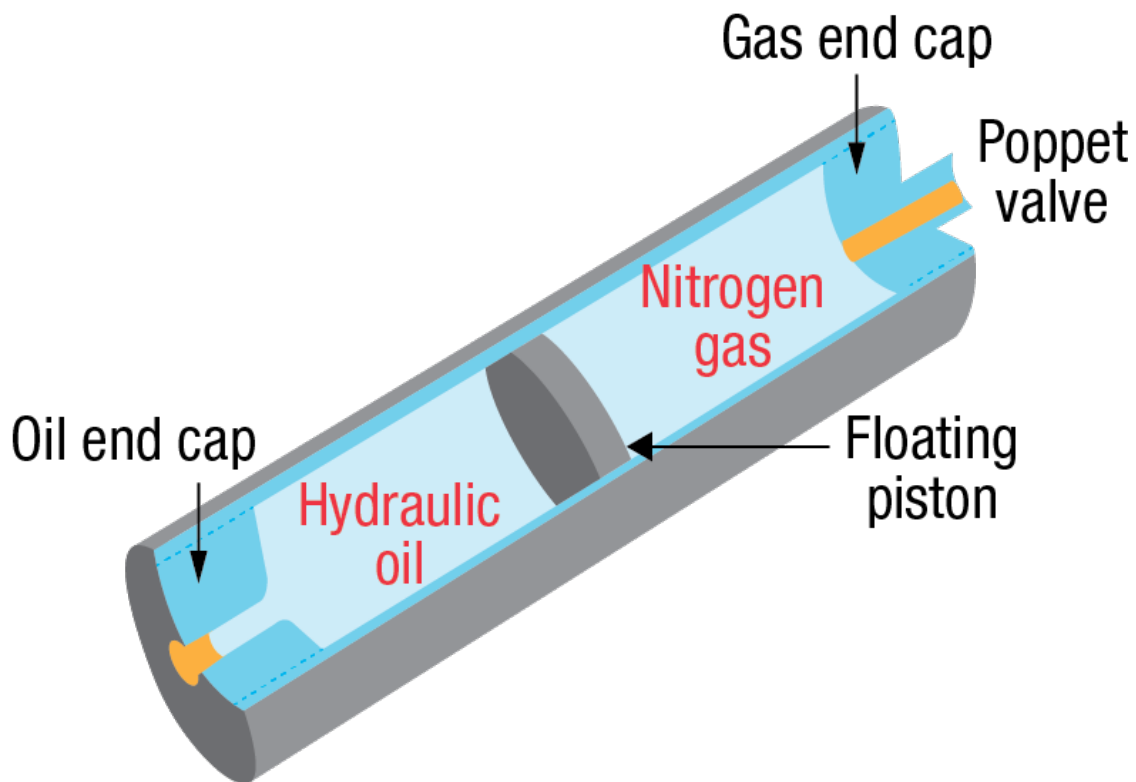
Schematic sectional view of a hydraulic accumulator. The piston is not fixed but is free to slide inside the accumulator barrel as the oil and gas pressures vary.

Accumulator failure is commonly attributed to the piston seal wearing out. The performance of the suspension system deteriorates, leading to poor ride quality, vehicle damage and stability issues.

When the piston seal fails, hydraulic oil leaks from the hydraulic chamber, passing the floating piston and entering the accumulator's gas chamber. As oil slowly fills the gas chamber, the high pressure exerted on the oil by the gas during operation can force gas to dissolve into the oil. There can be excessive foaming when the pressure is released (e.g. during maintenance). As gas bubbles from the oil, it can build to sufficient pressure that, when the hydraulic end cap is removed, the piston can be ejected from the accumulator.
