Government of Western Australia Department of Mines and Petroleum Resources Safety

Significant Incident Report No. 214

Subject: Haul truck collides with light vehicle in a designated controlled area

Date: 28 April 2015

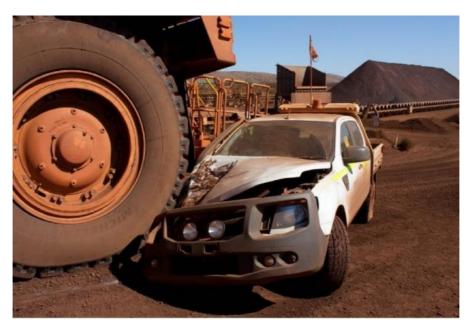
While heavy vehicles were relocating a stockpile during a night shift, a light vehicle entered the designated controlled mining area without following the correct process for entry. This resulted in the light vehicle colliding with a haul truck that was travelling at about 20 kilometres per hour.

After an empty haul truck passed through the single-lane controlled area, supervisors in the light vehicle assumed it was safe to enter the area and conduct a brief inspection. As they were leaving the dump site via a ramp, a loaded haul truck collided with the light vehicle. The light vehicle became entangled with the haul truck's emergency ladder and was pushed backwards about 40 metres down the recently watered ramp.

The haul truck only stopped when radio contact was established by the occupants of the light vehicle, who alerted the truck operator to the incident. Fortunately, no physical injuries were sustained during the collision.

- A light vehicle entered a designated controlled area where heavy vehicles were operating.
- The light vehicle occupants did not contact the senior operator in control of the area by two-way radio before entering the designated controlled area.

- The site's single-lane traffic management system increased the potential for a collision as it did not segregate light vehicles from heavy vehicles in the designated controlled area.
- Compliance with the safe system of work controlling the area was not monitored or enforced.
- The light vehicle occupants failed to recognise the potential collision risks when they entered the work area.
- The safe system of work did not specify separate requirements for supervisors entering the controlled area for inspection purposes.
- A procedure for accessing controlled areas had been created but had not been implemented.

Mine operators are reminded of the importance of developing safe work procedures that identify hazards and ensure adequate risk controls for work in controlled areas.

- monitor the effectiveness of, and compliance with, safe systems of work, and ensure all
 personnel understand the hazards and risks involved with vehicle movements on site (e.g.
 through training)
- remove single-lane traffic management systems, where practicable
- implement engineered traffic management solutions to segregate heavy and light vehicles, where practicable.
