Significant Incident Report No. 234

Subject: Light vehicle driven partly over edge of open stope

Date: 09 December 2015

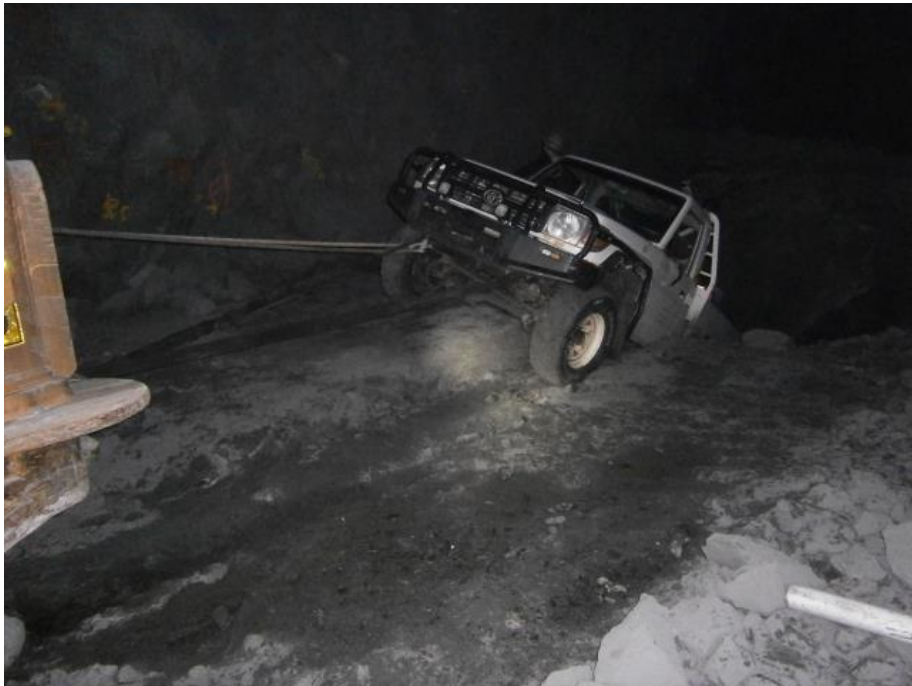
The vehicle reversed until the rear wheels dropped over the edge of the 18 metre deep open stope, and the frame bottomed out on the floor at the edge of the void. The vehicle's frame skidded 20 to 30 centimetres before stopping. The expected second set of signs had not been hanging in the access.

Light vehicle attached to loader with chain

- The open stope lacked appropriate hard barriers, allowing personnel inadvertent access to the void.

- Management relied on the lower order control of signage with no hard barriers to prevent access to the top of the open stope.
- The signage process in the site's signage procedure was inconsistent (i.e. reliance on a second sign being in place that was not).
- There was no official procedure for conducting a cavity monitoring survey.
- There was insufficient detail in the procedure for working around an open hole (which is different from working at heights).

- Hard barriers should be:
 - designed, constructed and located to prevent equipment accessing the edge of open holes
 - used in conjunction with lower-tier control systems (e.g. clear sign-posting, lockable barriers controlled by supervisors or managers)
 - wherever possible, installed before creating an open hole.
