Significant Incident Report No. 269

Subject: Structural failure of a corrugated steel water tank

Date: 12 November 2018

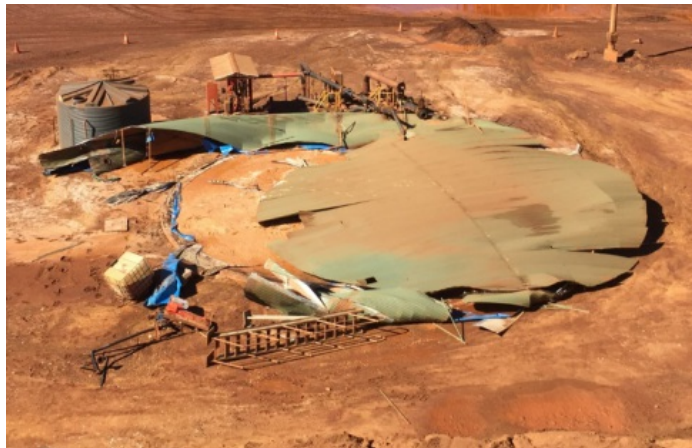
In May 2018, a 600,000 litre raw water tank failed. It was a rubber-lined steel construction. At the time of failure, the tank was near full capacity. The outrush of water affected an operational area of 24,000m², displacing pumping infrastructure, ladders and associated debris.

Water tank that failed

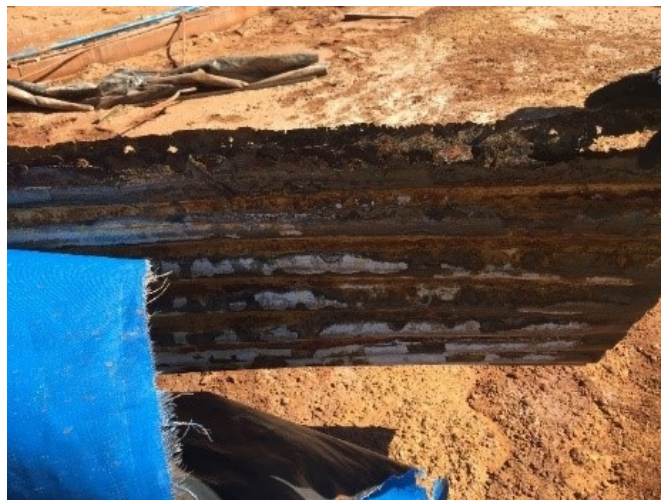
Corroded steel wall of tank

- The structural integrity of the water tank had deteriorated substantially due to corrosion.

- Inadequate inspection and maintenance management of the water tank.
- Failure to ensure the condition of the structure remains within the design limits.
- Failure to assess the structural integrity of the tank by a competent person with appropriate training and experience.

- Ensure tanks are only used in applications consistent with the original design intent.
- Use the tank manufacturer's guidelines, or a risk-based approach, to determine the nature and timing of inspections and monitoring that will periodically assess all tanks on-site to confirm structural integrity and provide advice on any remedial measures necessary.
- Ensure the structure and its components are maintained in a safe and stable condition.
- Ensure any repairs are undertaken by competent persons with appropriate training and experience.
- Rank all remedial measures based on risk and prioritise them.
