Significant Incident Report No. 282

Subject: Fall of ground in a development heading resulting in serious injury

Date: 10 August 2020

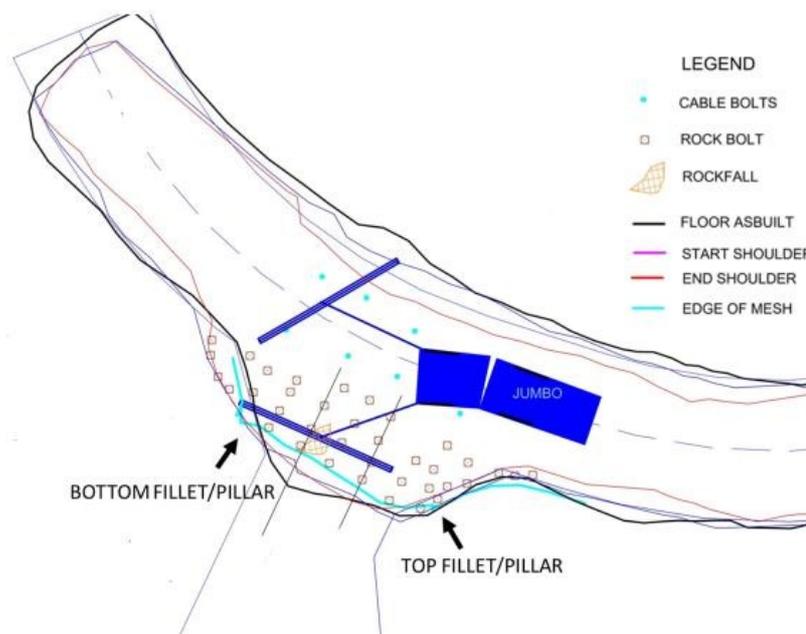
Plan view of the incident site.

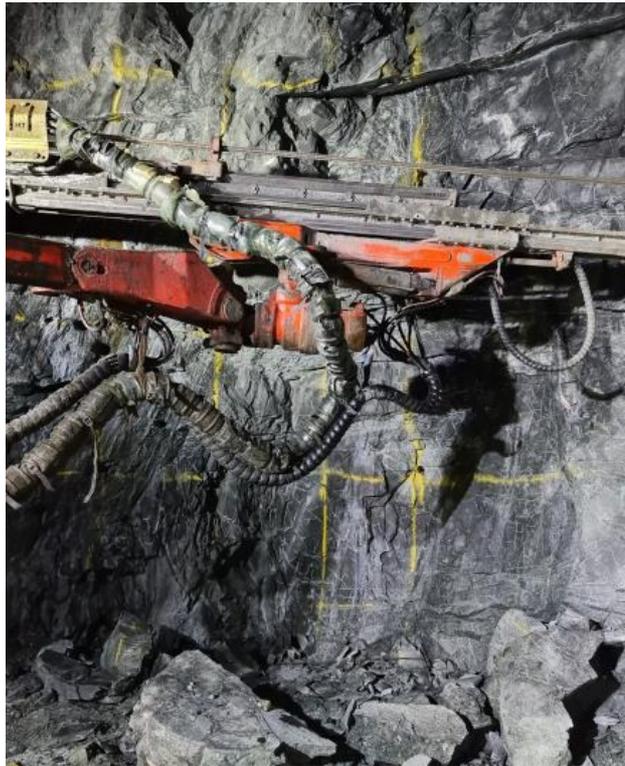
The rock dislodged from the bored face, from a geological structure, striking the two workers approaching the face to install lifter tubes.

View of the face from the bottom pillar. Note the geological structures on the face and large rock that struck the two workers.

- Use of an out-of-date rock mass model to assess the design.
- The planning and design process did not consider local geotechnical information at the newly established heading.

- Geological information was not available for the development heading due to infrequent mapping.
- Geotechnical inspections were not completed as per the Ground Control Management Plan.

- A large number of geological structures that indicate the presence of blocky ground were not identified prior to the incident.
- Excessive material fell from the backs during scaling, indicating the presence of poor ground conditions, however additional ground support was only installed on the side wall leaving the face unmeshed.

- Development methodology and jumbo setup resulted in rows on the face bored before all the lifter tubes had been installed.
- A 4.9 metre drill steel was used to establish the heading and may have impacted on directional control within fractured or blocky ground resulting in excessive damage to the perimeter and face.

- Establish a system that confirms adequacy of the geotechnical model used in the design process.
- Ensure planning and design incorporates up-to-date information from geological and geotechnical inspections before the commencement of new development accesses.

- Conduct an inspection by a competent person before survey direction is issued for new development accesses.
- Use a Trigger Action Response Plan (TARP) that include alerts and controls where excessive scaling/bogging occurs in development headings.

- Where over break is measured, ensure perimeter controls are implemented for all development, including fillets.
- Where poor ground is noted and the face is undercut, ensure all lifter holes are drilled and lifter tubes installed before boring of the face commences.

- Use a drill steel of suitable length when new development accesses are established.
- Provide the workforce with geotechnical hazard awareness training, to enable them to recognise geotechnical hazards and implement appropriate controls.

- Install face mesh (as a minimum) in all headings where poor ground conditions are expected and include additional measures, where appropriate, based on the inspection conducted by a competent person, or on the TARP.
