Dangerous Goods Significant Incident Report No. 03-16 and Petroleum Safety Significant Incident Report No. 02/2016

Switchboard fire caused by arc flash

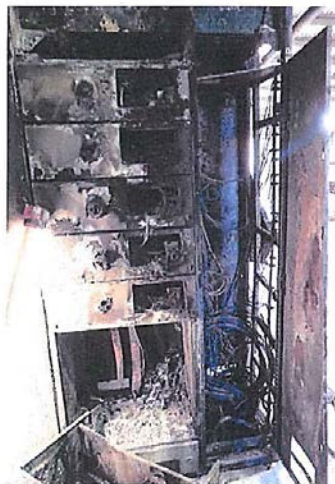
There had been a phase-to-phase arc fault on the line-side cables within a 185 kW 415 LV withdrawable motor starter in the switchboard's motor control centre (MCC). The fault escalated to the main bus on the same switchboard, almost completely destroying the 415 V MCC in the switchroom, damaging adjacent equipment.

The subsequent investigation found that the switchboard's MCC modules were heat damaged due to a high resistance connection to the main bus. These modules were used for both electrical and mechanical isolations over an extended timeframe. This is thought to have caused a high resistance connection which generated sufficient heat to escalate into an arc fault. The upstream 6.6 kV feeder protection failed due to a seized tripping mechanism in the contactor. The possibility for the latch roller to seize and fail was a known contactor vulnerability.

Damaged MCC modules

- The MCC modules were subject to a high resistance connection.

- Identify, risk assess and prioritise electrical equipment for refurbishment or replacement as necessary. Implement mitigation plans to address any residual risk.
- Periodically risk assess and address any issue in relation to electrical protection settings.
- A power system protection scheme needs to incorporate:
 - local back-up protection; or
 - remote back-up protection.

- Operate and maintain MCC modules in accordance with the original equipment manufacturer's (OEM's) specifications.
- Review the suitability of fire protection and suppression systems and change where necessary.

- Conduct, complete and record all maintenance and testing strategies and requirements.
- Complete periodic, close visual inspections of module line-side cabling where withdrawable MCC modules are used for both mechanical and electrical isolation purposes.
- Keep and make available, clear and easily understood electrical isolation and switchboard plans for all substation buildings.
