SIGNIFICANT INCIDENT REPORT NO: 109

FITTING OF TILE BOXES ON DRILLING RIGS

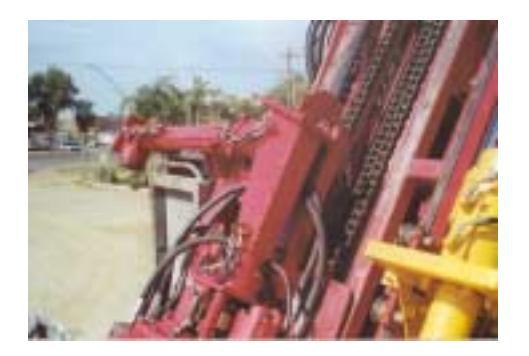
A driller was struck by a "tile box" assembly which fell from an RC Drilling Rig at a mine in the Goldfields. The "tile box" is a ceramic lined manifold assembly attached to the drill head designed to cope with the high air pressures and abrasive nature of the drill cuttings on the return side of the RC drilling process (see photographs).

"Tile box" Assembly mounted on drill head.

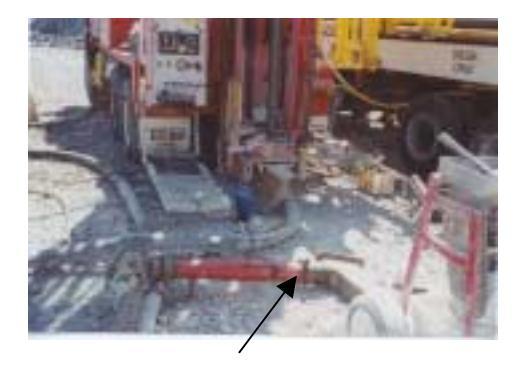
"Tile box" assembly after falling from mast.

The tile box assembly broke away from its welded support fitting and attachment bolts also sheared off from the drill head. The weight of the assembly and return hose attachments was estimated at 300kg.

One of the welded support bracket sections had failed prior to the day of the accident. The remaining weld broke on the day, presumably due to vibration of the high pressure hoses and attachments.

Two of the attachment bolts to the drill head had sheared off the day before the accident and had not been replaced.

The tile box had been replaced the weekend before the accident. In the past, tile boxes had been provided with a safety link whereby a safety chain could be attached to retain the assembly in the event of failed welds or bolts. A fabrication oversight resulted in the new box being supplied without a safety chain attachment. On investigation, it was also established that the new tile box was made for a different rig which had a different arrangement on the mast.

The facts that bolts had sheared and welds had failed indicated that the engineering design was inadequate for the loads placed on the tile box attachments.

An engineering design review was undertaken by an engineering firm and significant improvements were made to the design of the tile box and return hose attachments. This review included the provision of attachments for a safety chain arrangement to be incorporated in the design.

Where components which are an integral part of such plant are to be fabricated, proper engineering design should be undertaken (including a critical review of the finished design) and approved fabrication drawings should be provided to the persons carrying out the work.
