Government of Western Australia Department of Mines and Petroleum Resources Safety

Significant Incident Report No. 207

Subject: Potential for serious injury from uncontrolled rotation of rotary kiln dryer

Date: 20 October 2014

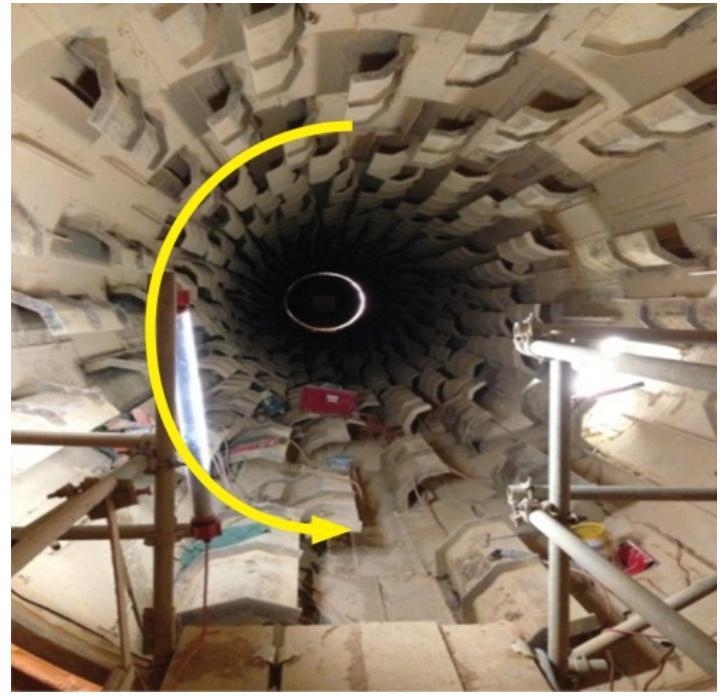
Three workers narrowly escaped serious injuries when the rotary kiln dryer they were working in unexpectedly rotated 180 degrees. They were about 6 metres from the exit platform at the end of the kiln, which is 26 metres long.

The workers were preparing to weld a lifter plate on the inside of the rotary kiln dryer's shell when the shell rotated.

Inside view of the rotary kiln dryer showing lifter plates welded to the shell and the direction of shell rotation during incident

- The rotary kiln dryer's shell was not restrained.
- There was no evidence that the rotary kiln dryer was energised or switched on at the time, and it appears that the rotation was caused by a shift in the centre of gravity during repairs in the dryer.

- The risk analysis for the task did not identify the potential for the shell to rotate. Consequently, there were no controls in place to prevent inadvertent rotation.
- The workers did not have the original equipment manufacturer's (OEM's) instructions regarding maintenance tasks, and there was no site procedure for the replacement of lifter plates.
- The workers undertaking the maintenance work were neither familiar with the task nor adequately supervised while undertaking the task.

- the potential for the centre of gravity to move and cause uncontrolled rotation is recognised and addressed
- OEM's instructions for the safe use and maintenance of such plant are available and understood by those using them
- workers are adequately trained in infrequently performed tasks and are supervised to enable them to perform these tasks safely.
