Significant Incident Report No. 237

Subject: Failure of crane head sheave

Date: 12 January 2016

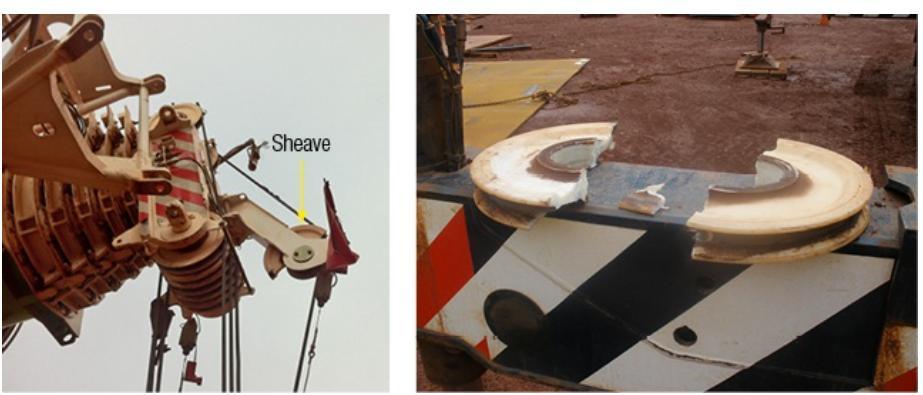
When the sheave was inspected later, it appeared to have been damaged prior to the lift.

Damage to nylon head sheave. Right. Half of the failed sheave for the auxiliary hook remained in place. Left. Sheave sections recovered after the incident.

• The damaged head sheave failed and fell from height during a lift.

Damage to the head sheave was not identified during the daily pre-start inspection of the crane by workers.

Check all sheaves for alignment, damage (e.g. cracking), wear, mobility and extreme soiling before starting a crane operation.
