Background

The historical abandoned mine site known as Black Diamond is located within the town of Allanson approximately five kilometres west of Collie in the South West of Western Australia.

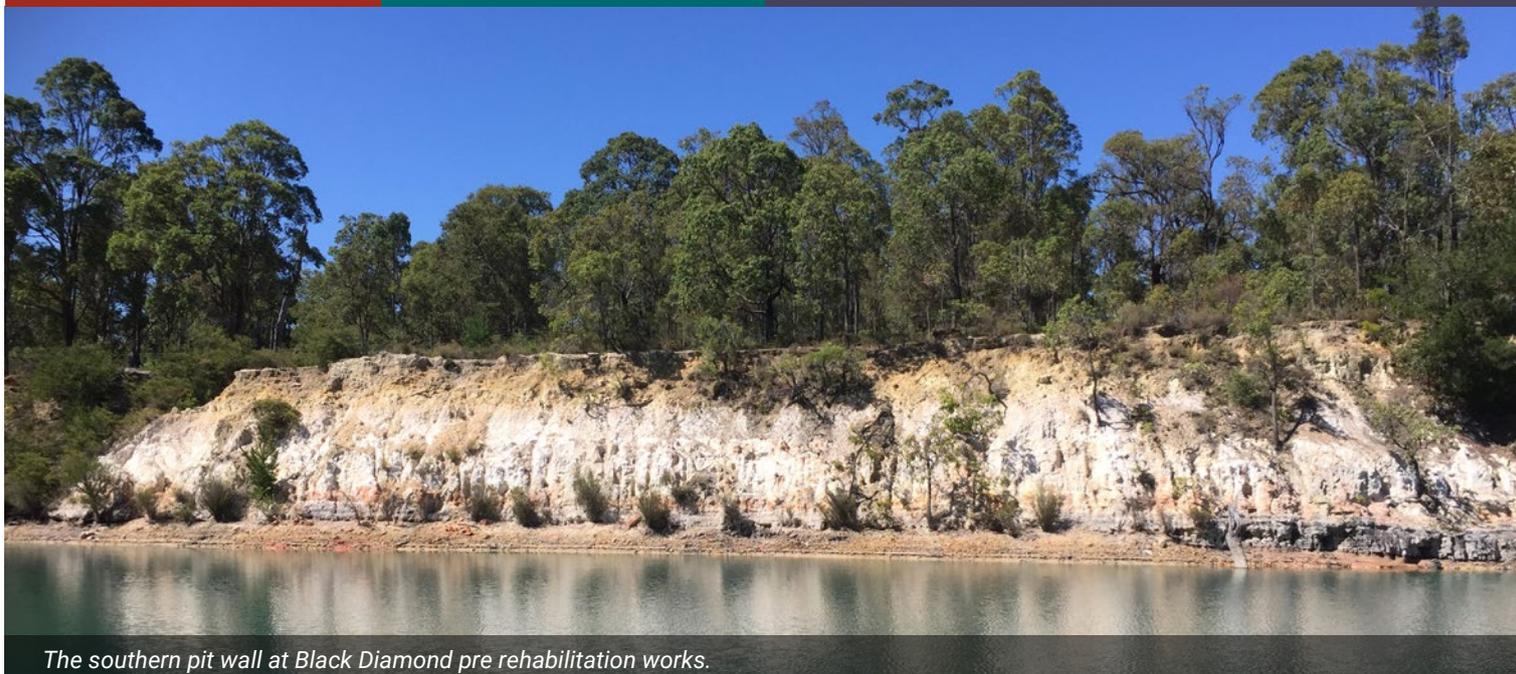
The southern pit wall at Black Diamond pre rehabilitation works.

Earthworks to batter down the southern pit wall were completed in October 2016 in accordance with the engineering design plan. This work was undertaken to reduce the public safety risks associated with pit wall failure and people falling, diving or jumping into the lake. Erosion management works on the western end of the pit lake were also undertaken.

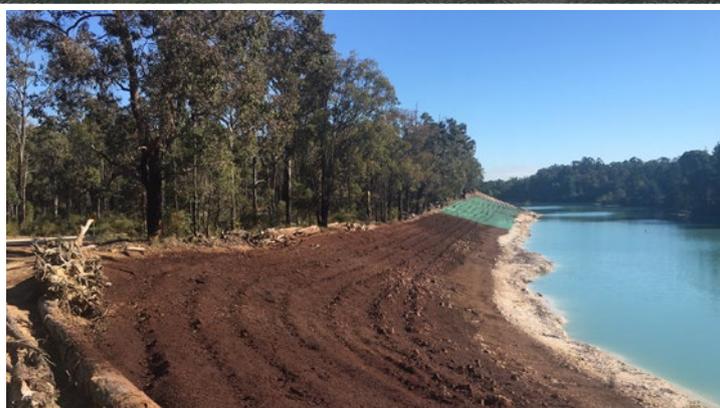
The application of growth medium on the slope.

Following the approval of the project's revegetation strategy by relevant stakeholders, the Abandoned Mines Program sought interest from local contractors and suppliers to help revegetate the Black Diamond project area. The revegetation works involved the distribution of native seed and planting of native tubestock as well as the management of weeds and the spreading of mulch to stabilise topsoil and reduced erosion.

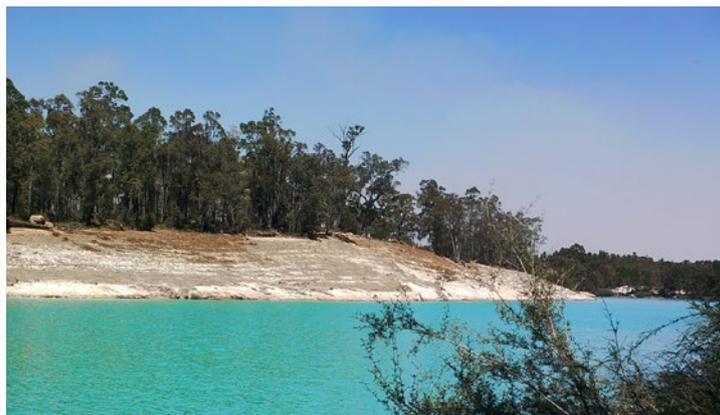
The southern pit wall at Black Diamond post rehabilitation works.
