## Mines Safety Bulletin No. 178

**Subject:** Working on open pit walls using rope access systems

**Date:** 10 August 2020

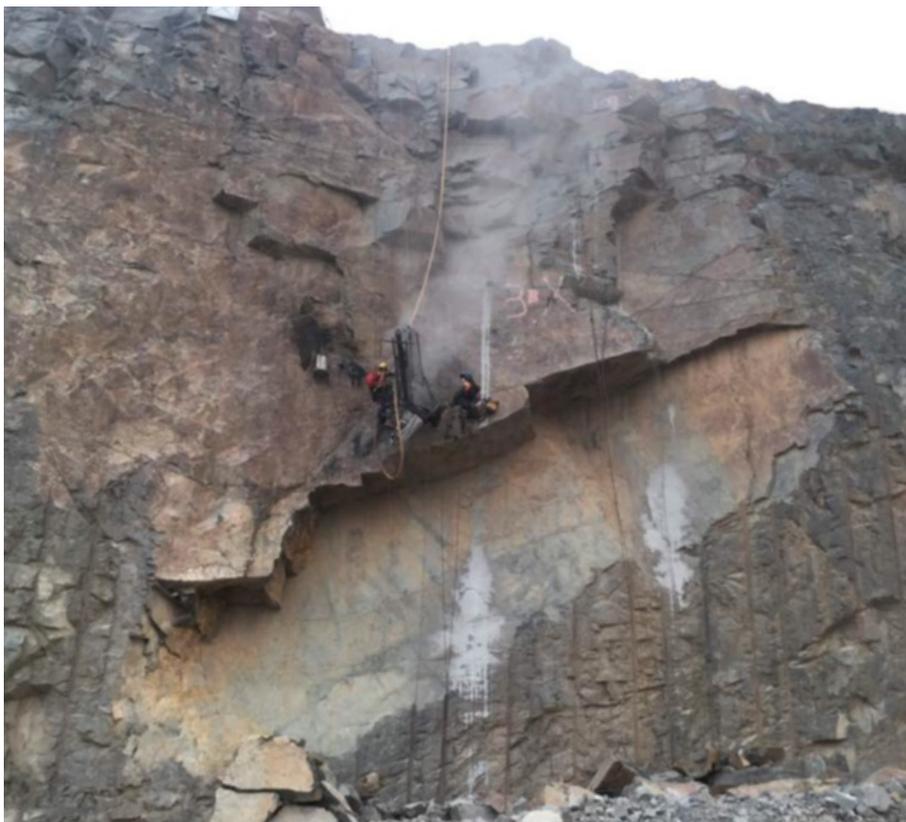
Workers drilling pit wall using rope access
