Mines Safety Significant Incident Report No. 169

Suspension component ejected under high pressure during maintenance – fatal accident

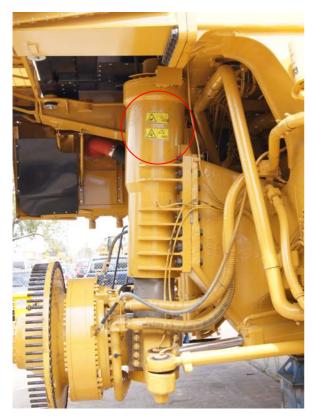
Figure 1 Examples of warning labels (photographs courtesy of WesTrac Pty Ltd and Caterpillar)

Decal warns of (a) crush hazard and (b) requirement to support vehicle and consult OEM manual before maintenance

- ensuring maintenance personnel
 - are appropriately trained and competent to carry out the task
 - follow original equipment manufacturer (OEM) service requirements and ensure any stored pressure is released in a controlled manner or is effectively isolated;
- where possible, fitting and maintaining warning labels to plant advising of any serious hazard (Figure 1); and
- maintaining effective communication between work groups and shifts, including detailing the work performed and the status of incomplete procedures.

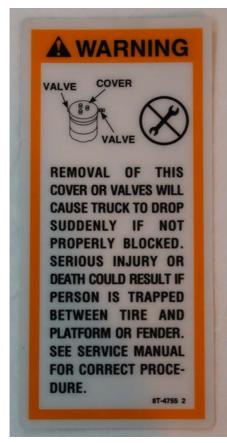
Warning label specific to stored energy hazards. Decal warns of (a) high-pressure hazard and (b) requirement to release pressure and consult OEM manual before maintenance
