Significant Incident Report No. 212

Subject: Fall from height at mobile screening plant

Date: 23 January 2015

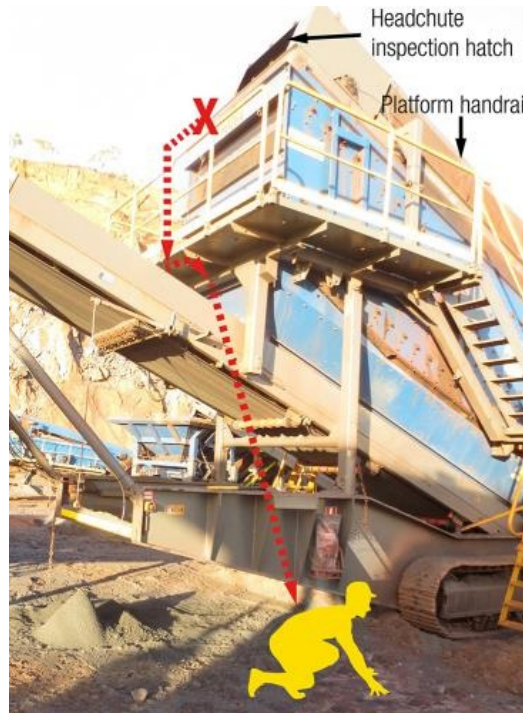
To inspect the headchute of a mobile screening plant, a supervisor climbed the steelwork above the elevated platform and handrail to access the headchute inspection hatch. As he opened the headchute inspection door, which weighed more than 10 kg, it came away from its hinge pins and fell onto the elevated platform. The supervisor lost his balance. He fell backwards over the top handrail onto the conveyor, about 3 m below, and then to the ground, a further 3.5 m below that. Fortunately, he was not injured.

Photograph showing the location of the headchute inspection hatch on the mobile screening plant and the supervisor's fall path

- The design of the mobile screening plant does not offer safe access to the headchute inspection hatch — the hatch cannot be reached while standing on the elevated platform.
- The inspection door's design allows it to easily detach from its hinge pins.
- The supervisor was working at height without fall protection.

- The elevated platform handrails were not sufficiently high to prevent a fall from an elevated position above the platform.
- Although a site working-at-height procedure was available, the potential to fall from height was not identified and, therefore, controlled for the task of inspecting the headchute.
- No risk assessment, such as a job hazard analysis (JHA) or a job safety analysis (JSA), was conducted for the task.

In accordance with Australian Standards AS 1657 and AS 4024, designers, manufacturers, importers and suppliers of mobile screening plant should:

- ensure the designs of elevated screening plants and conveyors are reviewed to identify hazards associated with the plant
- conduct a risk assessment of the tasks workers are likely to undertake on the plant to identify where they may be exposed to the identified hazards, including the risk of falling from height
- ensure adequate control measures are in place
- provide information to mine operators regarding the risk assessments, control measures and safe systems of work for the plant.

- ensure workers are trained to identify fall-from-height hazards they might encounter
- review elevated screen plants and conveyor systems to identify all reasonably foreseeable hazards, including specific tasks that expose workers to the risk of falling from height
- conduct a risk assessment to identify hazards and reduce worker exposure, so far as is practicable
- review and, where necessary, update site procedures to ensure controls are adequately documented in the safety management system, including the need for specific risk assessments when working at height.
