Significant Incident Report No. 281

Subject: Underground mine workers tipped out of work basket used with integrated tool carrier

Date: 07 May 2020

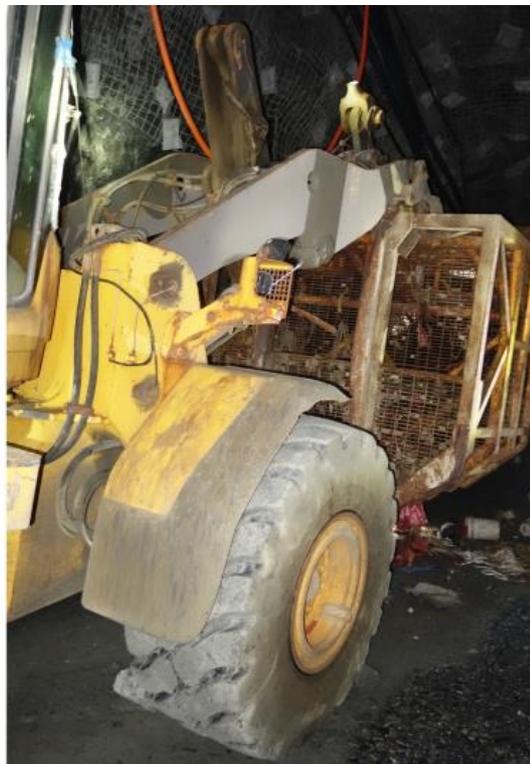
While hanging the electrical cable for the jumbo box from the backs (i.e. ceiling) of the drive, there was a catastrophic failure of the dog bone linkage on the boom of the ITC resulting in the work basket suddenly and unexpectedly rotating forward. The two workers in the work basket were thrown onto the ground. They received serious, but non-fatal injuries.

Both workers were using a fall protection system at the time, consisting of full body harnesses and fall restraint lanyards connected to anchor points on the work basket. However, the work basket was only a short distance above the ground and the lanyards were too long to restrain the fall.

View of work basket from wheel 1 position with incident scene undisturbed.

The dog bone linkage failed suddenly and catastrophically allowing the quick hitch to pivot freely under gravity. The cantilevered mass of the work basket and contents (gross mass in excess of 1500 kg) resulted in a very sudden and energetic rotation of the work basket which threw the two workers out onto the ground.

The fall protection system that the workers were using was designed to control the consequences of a much greater fall from height. Shorter lanyards or the additional use of fall arrest devices may have prevented the workers from impacting the ground.

- Fall protection systems used when working from underground work baskets should be reviewed in line with the guidance in AS/NZS 1891 Series Industrial fall-arrest systems and devices.
- An appropriate combination of height safety equipment, including fall restraint and/or fall arrest devices, should be considered in each particular case to ensure the greatest possible security against workers impacting the ground.
- ITCs and work baskets used for working at height need to be designed, manufactured, tested, periodically inspected and maintained, all by competent persons to ensure that the risk of ejection from the work basket through any component failure is reduced so far as is reasonably practicable.
