DEPARTMENT OF  
**MINERALS AND ENERGY**  
WESTERN AUSTRALIA

**Explosives and Dangerous Goods Act 1961**

**Dangerous Goods (Transport) Act 1998**

**SUMMARY OF ACCIDENT REPORTS**

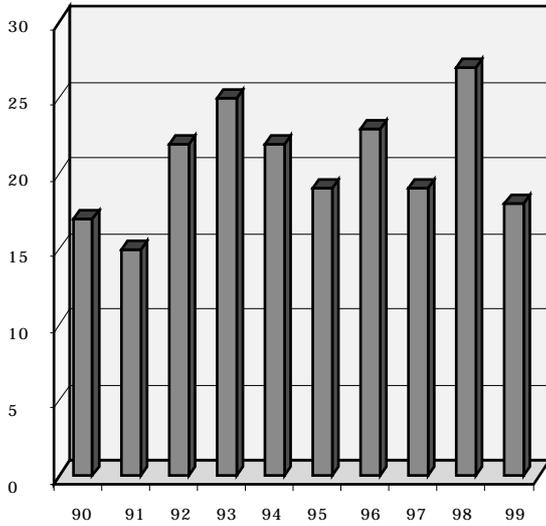
### Transport Accidents

The number of dangerous goods transport accidents recorded in 1999 was less than the number recorded in 1998 and less than the ten-year average of 21.

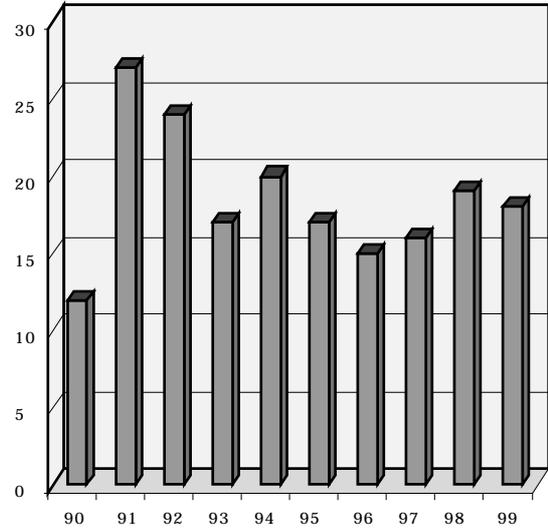
### Storage Accidents

The number of storage accidents recorded in 1999 was one less than recorded in the previous year, however it is equal to the average for the last ten years.

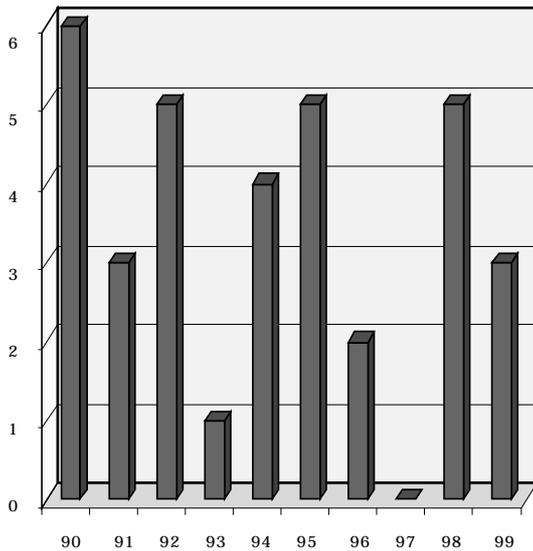
### Explosives Accidents

Three accidents were recorded in 1999, just under the ten-year average of three and a half.

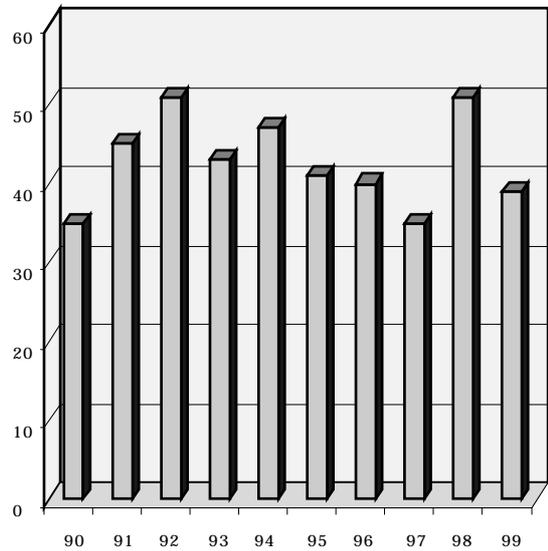
### Total Accidents

The total number of accidents recorded in 1999 was less than the number recorded in 1998 and is less than the ten-year average of 43.

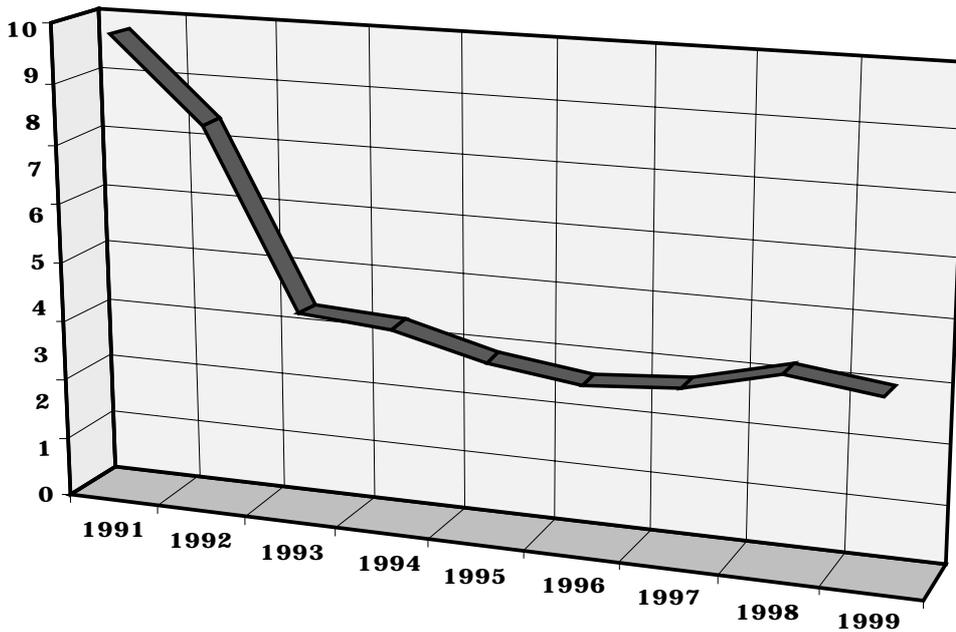
### Number of Accidents per 1 000 Licensed Premises

The 1999 figure is similar to that recorded in recent years, confirming the trend of about three accidents per 1 000 licensed premises.

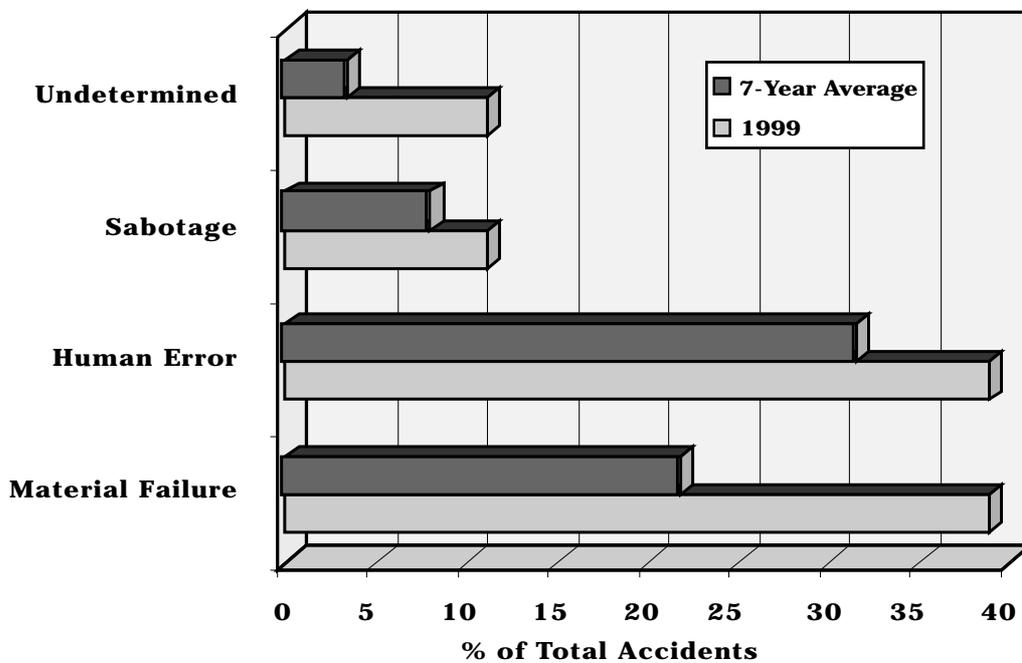
### Causes of Storage Accidents - (1999 vs 7-Year Average)

In line with previous years, the major causal group of storage accidents is the failure of people to follow standard operating procedures (reported as human error), and material failure.

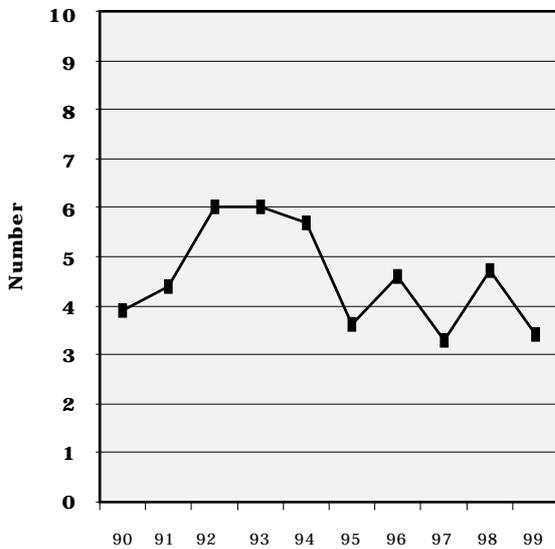
**Number of Accidents per 1 000 Licensed Vehicles (Bulk Only)**

The 1999 value is lower than in 1998 due to a lower number of bulk vehicle accidents.

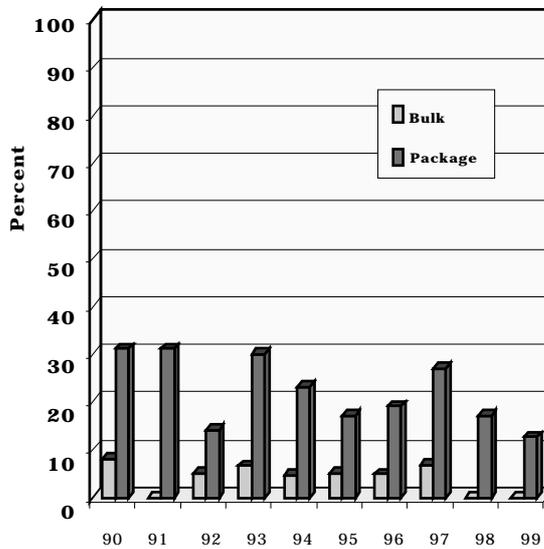
**Non-Complying Vehicles in Accidents (Bulk/Package)**

While bulk vehicles have very good compliance with the Australian Dangerous Goods Code, there is room for improvement for packaged vehicles; substandard stowage is the main problem.

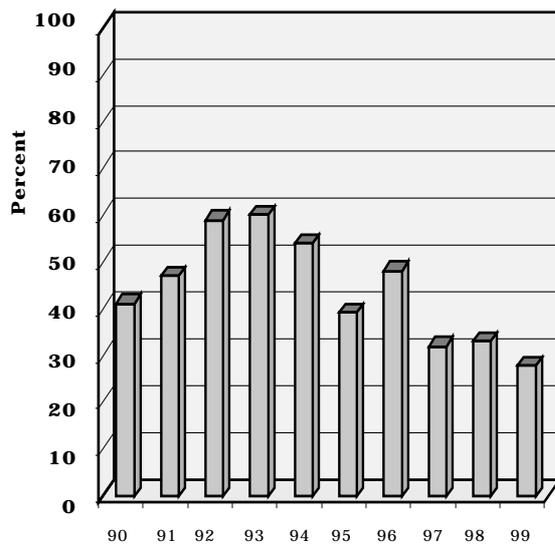
**Percentage of Accidents Caused By Non-compliance**

The above figure includes only non-compliance from dangerous goods legislation and/or standard operating procedures, it does not include deviation from road safety legislation.

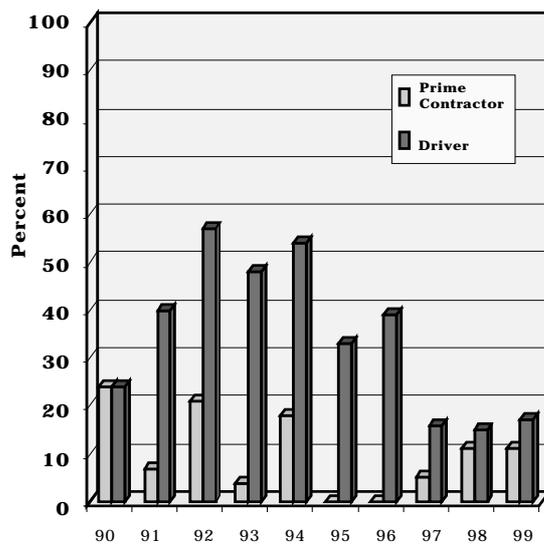
**Contribution to Non-compliance Caused Accidents as a Percentage of Total Accidents**

The introduction of compulsory refresher driving course in January 1997 has possibly decreased the number of accidents caused by the driver in subsequent years.
