Dangerous Goods Safety Significant Incident Report No. 01-14

Sulphuric acid leak damages storage facility

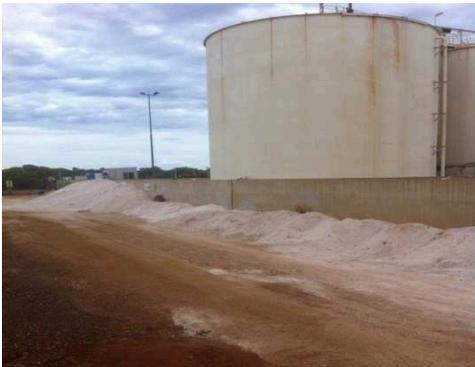
However, hidden damage to the storage tank was revealed about 11 months later when the tank floor apparently split from the wall and there were leaks from the structure's ring beam. About 3,000 L of sulphuric acid was released in the second spill and contained in the bund. The spill was neutralised using limestone, and the reaction product (gypsum) removed and disposed of.

Limestone (piles of pale material) was used to neutralise the second acid spill and support the bund walls

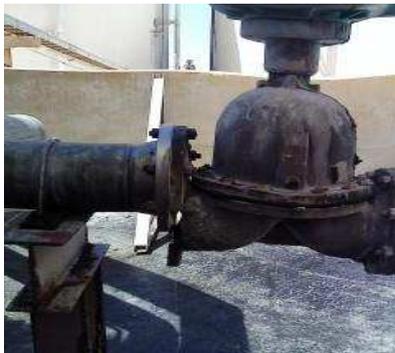
About four weeks later, corrosion and the physical stress from the heaving of the foundations and supports appears to have caused a valve linking the four tanks in the farm to fracture. Between 250,000 and 500,000 L of sulphuric acid escaped into the secondary containment. Again, the acid spill was neutralised and the reaction product removed and disposed of.

Valve damaged during third acid spill

- The tank and valve design lives were exceeded, and the inspection, testing and maintenance regimes were inadequate to manage the asset's integrity.
- The material used to construct the secondary containment bund was not fit-for-purpose.
- There was no system to detect leaks.
