## Mines Safety Bulletin No. 116

**Subject:** Use of mobile elevated work platforms (MEWPs) within or adjacent to structures with restricted access

**Date:** 08 December 2014

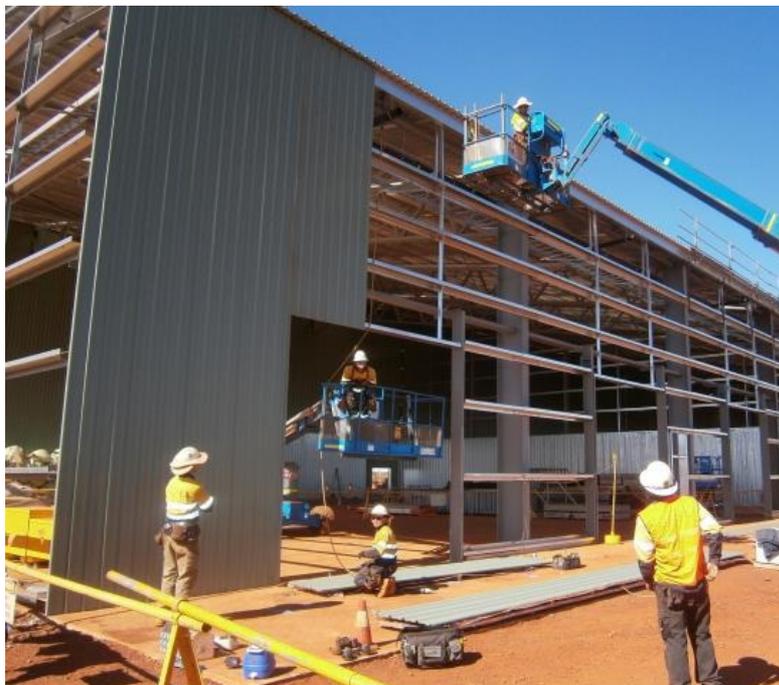
MEWPs are being damaged and people injured due to basket placement in or adjacent to a structure with restricted access.

- an employee attempting to manoeuvre into a steel structure was seriously injured when he became trapped between the MEWP control panel and framework
- all eight connecting bolts between a MEWP basket and rotator assembly sheared when the basket came into contact with a steel structure
- a MEWP basket knuckle was damaged when the basket became entangled in a steel structure while being withdrawn.

MEWPs being used in and near a structure with restricted access

When using a MEWP, the following measures are recommended:

- conduct a pre-start check before a machine is operated to ensure it is responsive to control commands
  - keep all parts of their body within the confines of the MEWP basket while in operation

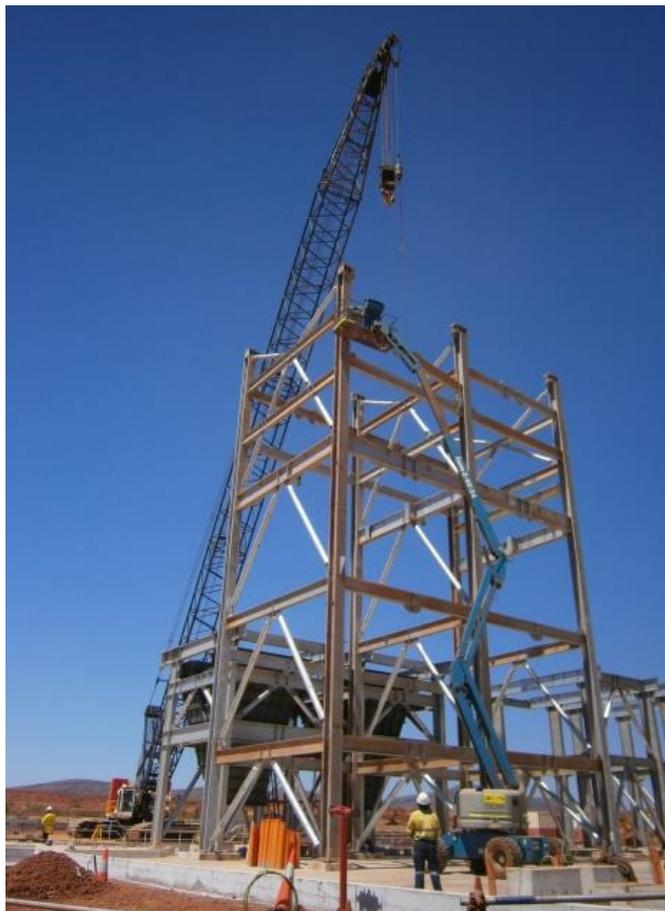
- spotters not receiving competency-based training, leading to incorrect positioning to see and advise operators on hazards
- risk assessment not identifying potential for:

- view of work to be obscured, leading to inappropriate spotter positioning or insufficient spotters
- MEWPs not being maintained to original equipment manufacture (OEM) requirements, leading to loss of control of movement.

Spotter has obscured view of work being undertaken by MEWP operator and might not recognise potential for interaction with other activities

- spotters should
  - be in a position to see and advise on hazards
  - establish suitable communications with the MEWP operator and other work parties in the vicinity

- not be distracted by doing other tasks while the MEWP is in use
- maintainers should
  - maintain each MEWP onsite to OEM requirements so it operates as expected.
